The Role of Microstructure in
the Fast Fracture of Multipass
Welds Deposited Using
E-10018-M1 Electrodes

**Ship Structures and Materials Division
Aeronautical and Maritime Research Laboratory**

DSTO-TR-0383

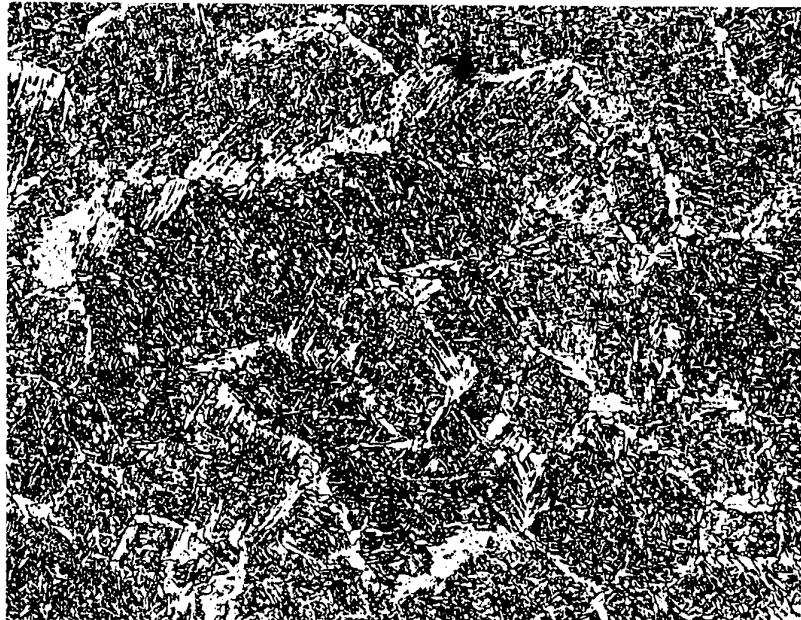
Figure 1.(b) Detail of Figure 1(a). X500

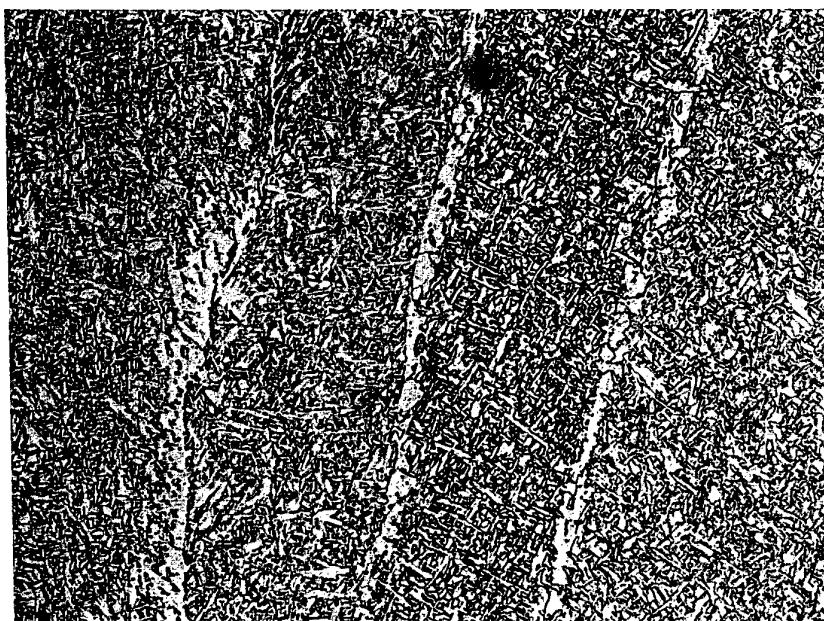
Figure 2. (c) Optical micrograph of transverse section of E-10018 weld metal from an explosion bulge plate. Note the continuous networks of pro-eutectoid grain boundary ferrite. Nital etchant. X200

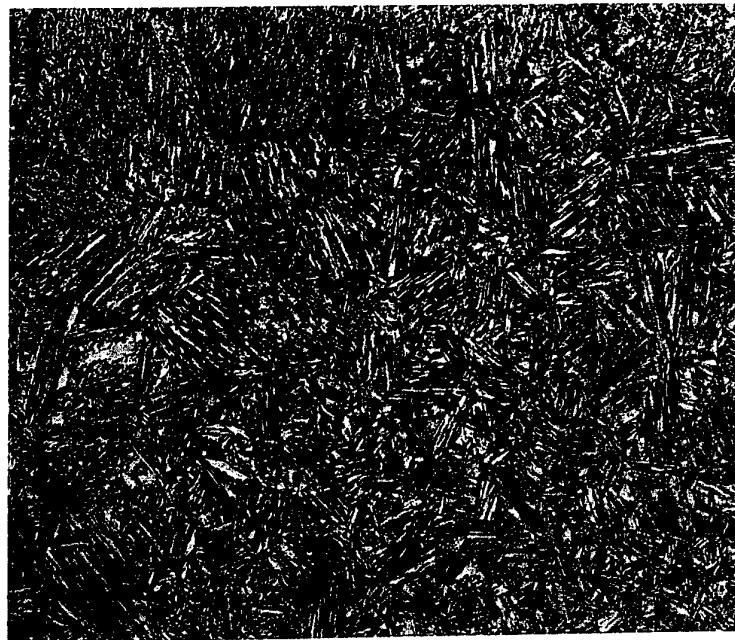
Zones within a weldment are reheated by subsequent weld passes. Intercritically reheated zones, within the E-10018 multipass weld and in the heat affected parent metal, contain semi-continuous chains of brittle high-carbon martensite-austenite particles (Figure 4 and 3 respectively). These particles give rise to local brittle zones and have been the subject of a number of recent structure-property relationship studies [6,7,8,9,10].

Figure 3.(a) Optical micrograph of intercritically reheated grain coarsened HAZ in BIS 812 EMA. X200

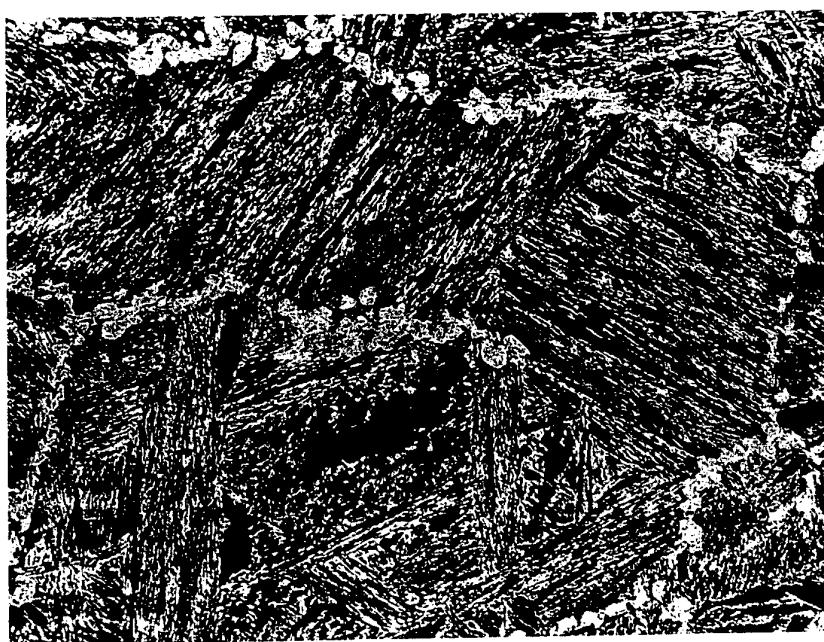
Figure 3(b) Electron micrograph of martensite-austenite particles decorating prior austenite grain boundaries. X575

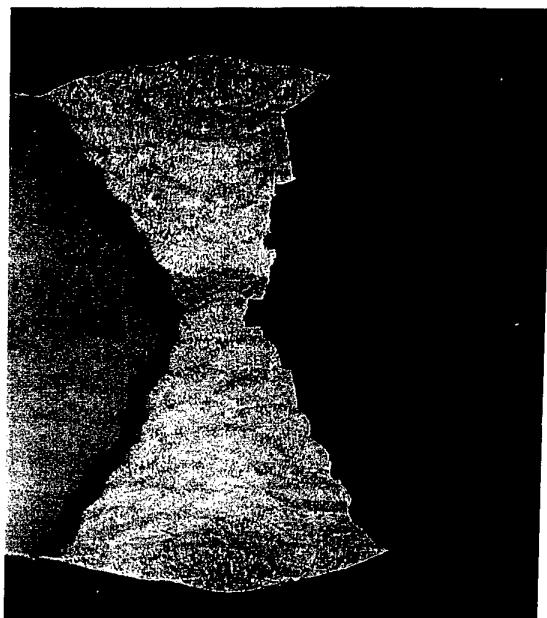
However, information gained from metallographic sections through the fracture, points to the significance of the grain boundary ferrite in the fracture process. There are a number of steps in the fracture path, shown in Figure 5, which are at a high angle to the overall fracture. These steps link regions of as-deposited weld metal where the

It has been shown above, that although the fracture is not microstructurally controlled in the reheated weld metal, grain boundary ferrite is the preferred fracture path in the as-deposited weld metal. In those regions, it is proposed that fracture occurs along the grain boundary ferrite in the stress field ahead of the advancing crack. As the crack advances, these cracks become linked by shear walls, which form large steps in the fracture seen in Figure 5.

Figure 5. Transverse metallographic section through the longitudinal fracture. The tension side of the explosion bulge plate is seen at the bottom of the photo.

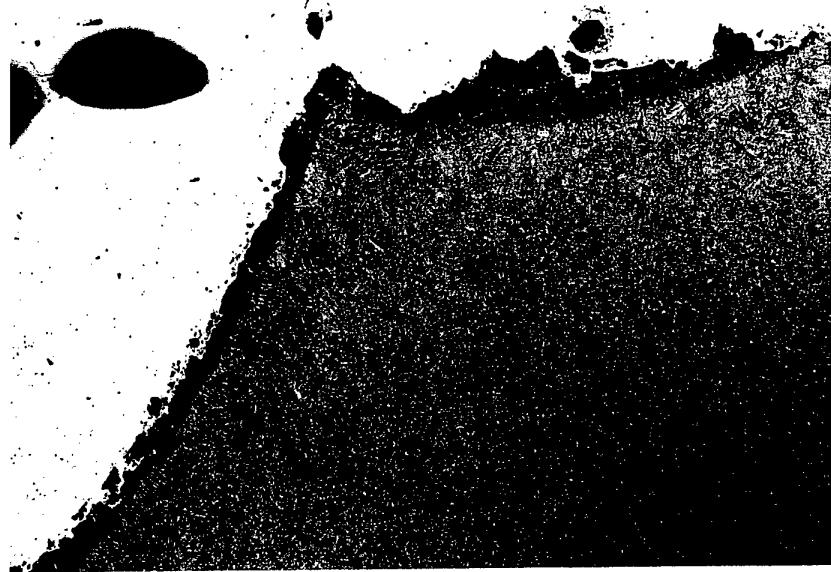
Figure 6. Optical micrograph showing the longitudinal fracture running immediately adjacent to a fusion boundary. X50

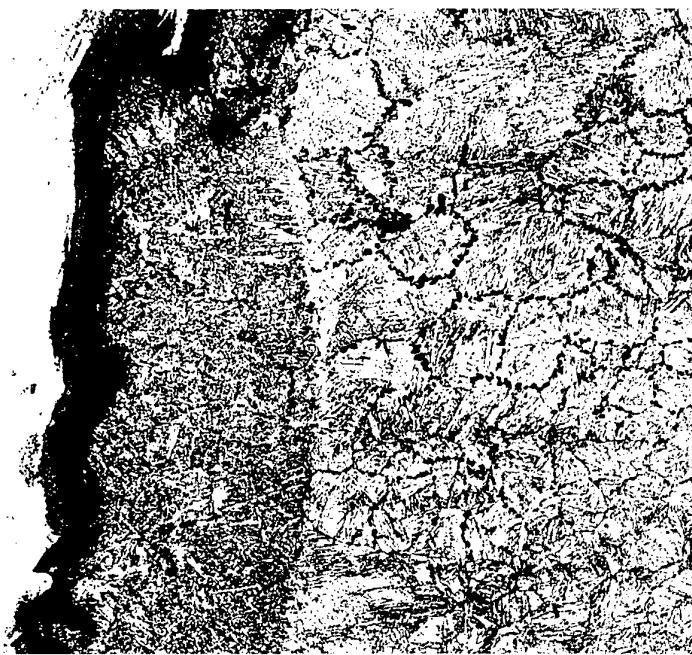
Figure 7. Optical micrograph of the fracture in the weld metal next to the fusion boundary and showing no preference for the inter-critically reheated grain coarsened HAZ. X200

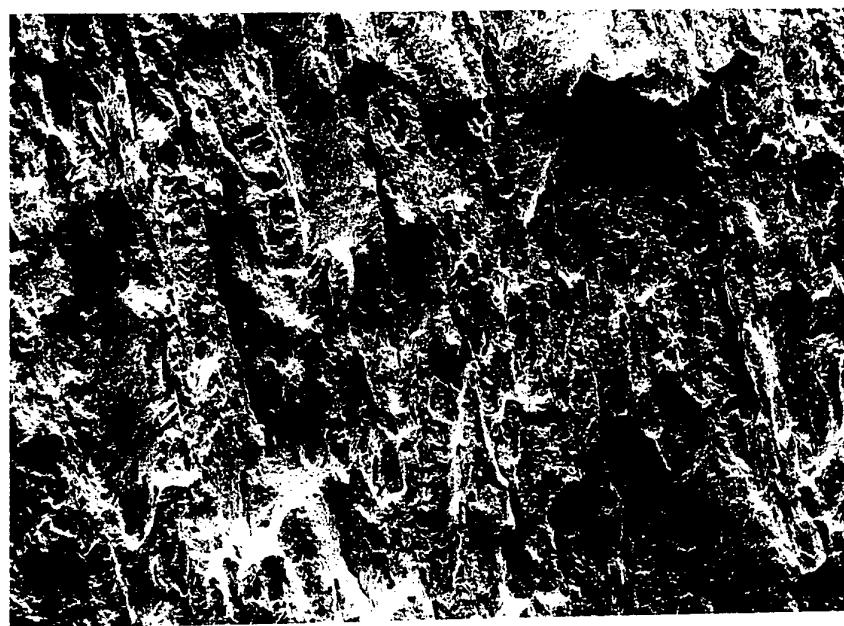
Figure 9. Electron micrograph of fracture through as-deposited weld metal. X50

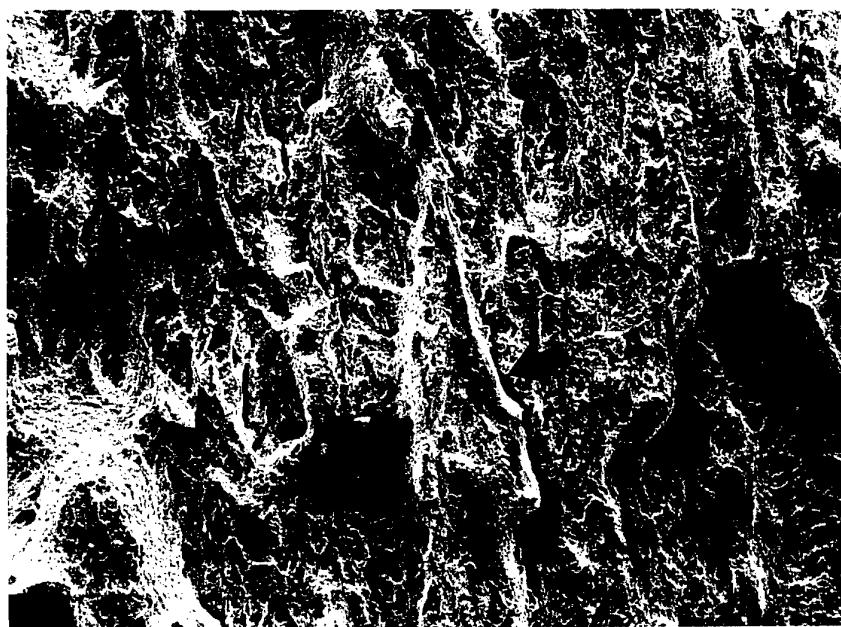
Figure 10. (a) Brittle intergranular fracture along a prior-austenite grain boundary in the as deposited weld metal (indicated by the black arrow). X100

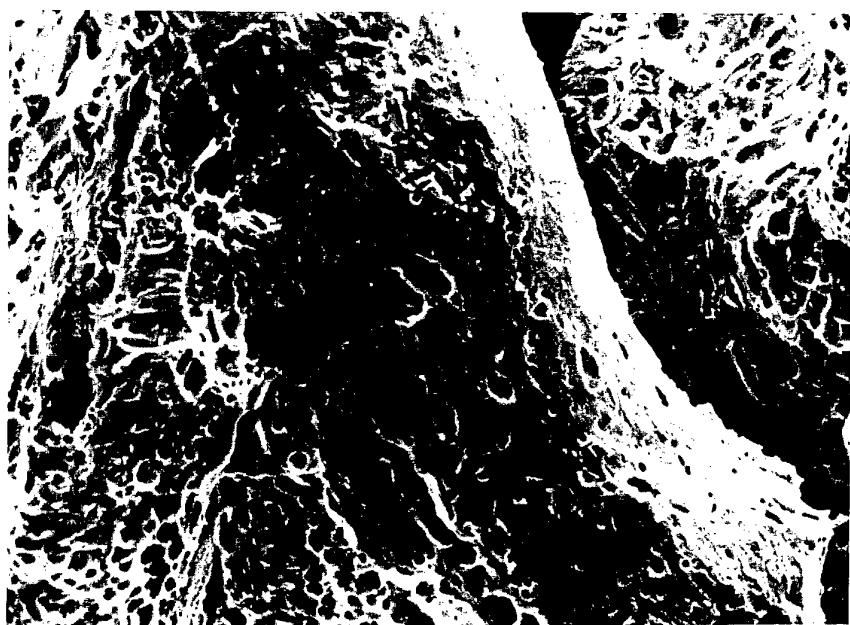
Figure 10. (b) Detail of the intergranular fracture shown in Figure 10 (a). X1000

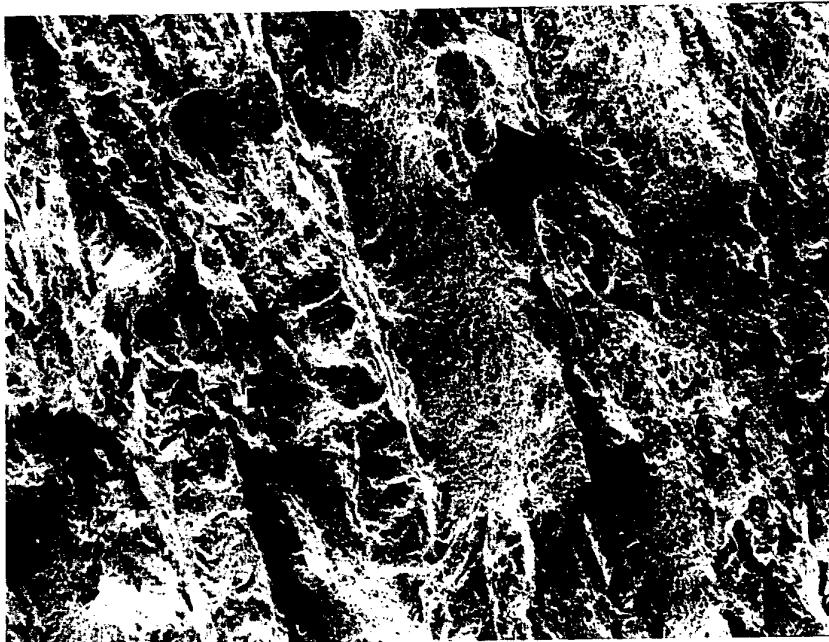
Detailed examination of the fracture surface revealed a mixed mode of ductile failure (~85%) and quasi-cleavage (~15%) in the as-deposited weld metal. In those regions where the fracture intersected the as-deposited weld metal the fracture face is similar in morphology and dimension to the columnar structure of the as-deposited weld metal (Figure 9). A small component of the fracture in these regions is brittle intergranular, with respect to the columnar prior-austenite structure (Figure 10). The vast majority of the fracture is ductile with numerous shear walls evident. A number of features appear to be cleavage facets (Figure 11) but on closer inspection these all exhibit limited ductility (Figure 12).

Figure 11.(a) Fracture through the as-deposited weld metal. The fracture is largely ductile, but it appears to have a number of cleavage facets (indicated by black arrows). X100

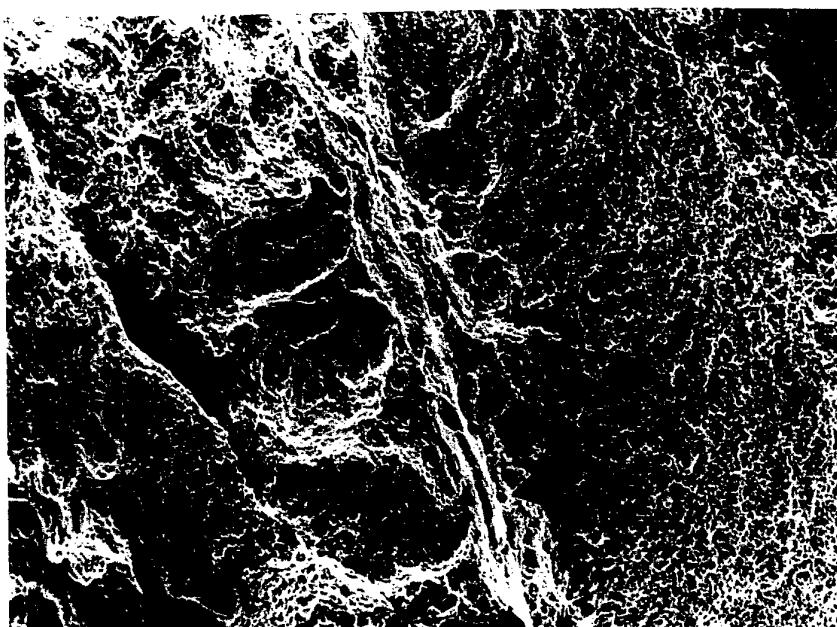
Figure 11.(b) Magnified overview of "cleavage facets". Note the brittle intergranular fracture indicated by black arrow. X280

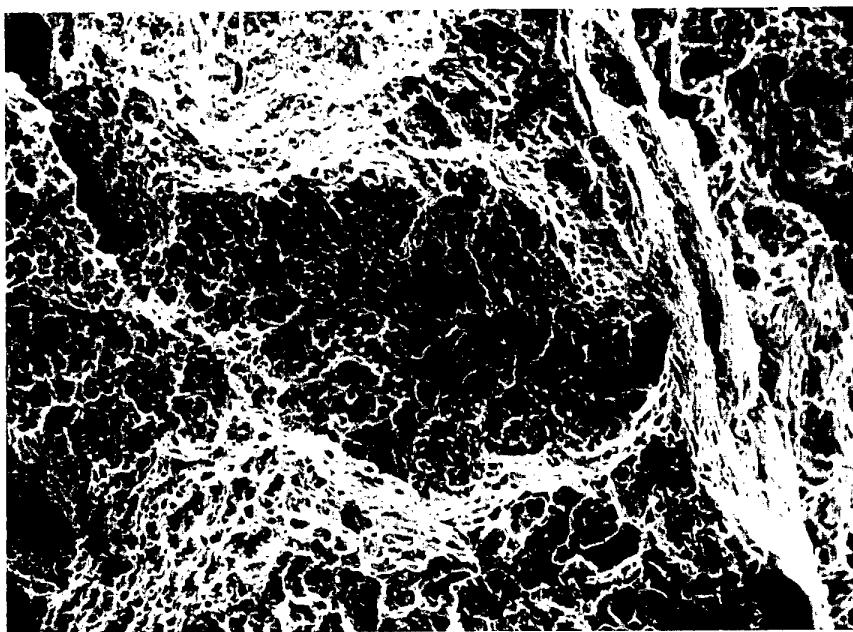
Figure 12. Detail of the fracture showing varying degrees of ductility found in the "facets" (a) Relatively large ductile component of a "faceted" region. Also note the featureless brittle intergranular fracture at the far right of the micrograph. X700

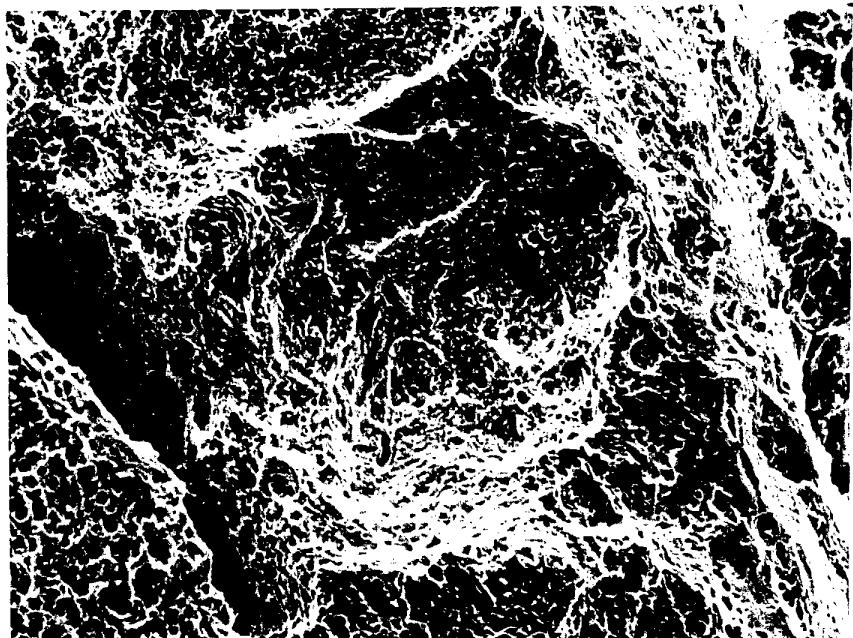
Figure 12 (b) A "faceted" region with a reduced, yet substantial, ductile component. X700
